ASBESTOS MANAGEMENT PLAN

Auckland Film Studios

12 Hickory Avenue Henderson, Auckland

Project ID: ECON3748-AMP

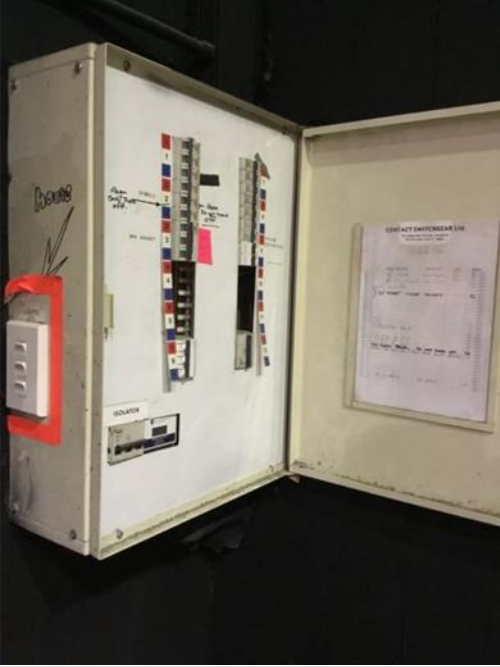
<p>Switchboard backing and insulating rope (flash guard) behind the fuses in the electrical box in Studio 2, on the southern side of the building</p>	Presumed ACM - Unable to sample due to live electrical services	Good Condition; no visible damage	<1m ²	Non-Friable	Very Low	Presumed Asbestos	7 – Very Low	<ol style="list-style-type: none"> No urgent remedial action required. Notify all contractors of the materials presence before works commence in this area. Confirm the presence or absence of asbestos prior to refurbishment or demolition. Re-inspect condition periodically. Manage material in accordance with asbestos management plan (AMP).

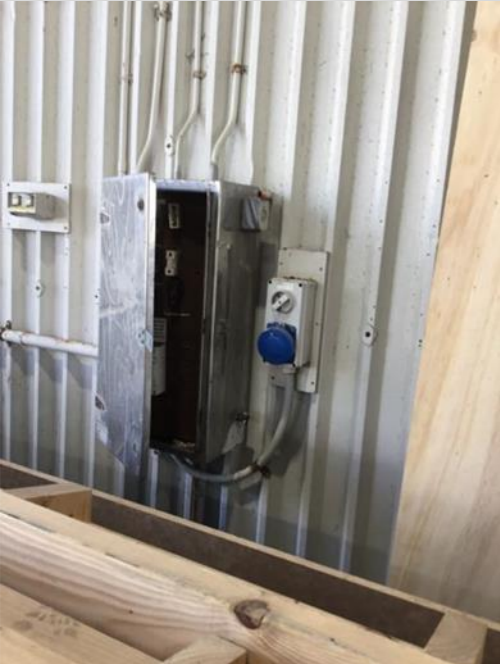
<p>Switchboard backing and insulating rope (flash guard) behind the fuses in the electrical box external to Studio 1, by Canopy 17</p>	Presumed ACM - Unable to sample due to live electrical services	Low Damage; few visible scratches, surface marks and broken edges	<1m ²	Non-Friable	Very Low	Presumed Asbestos	7 – Very Low	<ol style="list-style-type: none"> No urgent remedial action required. Notify all contractors of the materials presence before works commence in this area. Confirm the presence or absence of asbestos prior to refurbishment or demolition. Re-inspect condition periodically. Manage material in accordance with asbestos management plan (AMP).

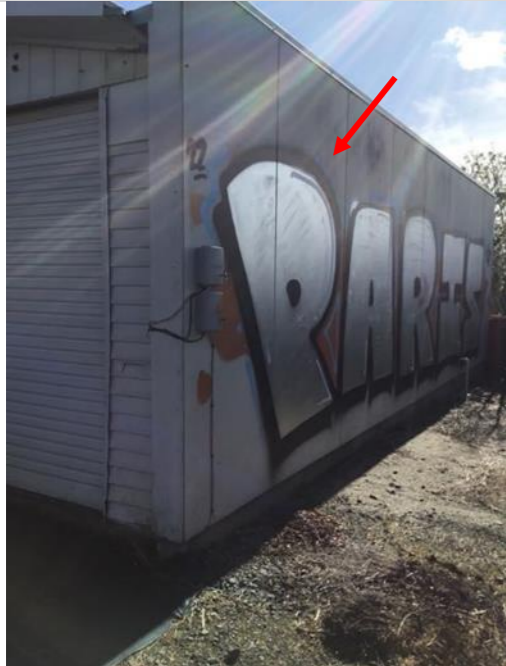
Fibre cement wall panels on the exterior of the building.	Sampled # 1 Laboratory Reference Number S11469-1	-	10m ²	-	-	Asbestos NOT detected	N/A	N/A

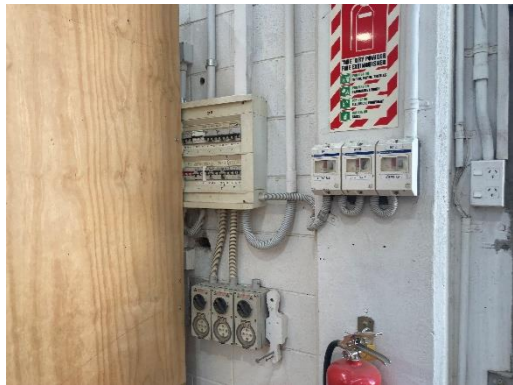
Electrical switchboards, flash guards and fuse backings	Presumed ACM - Unable to sample due to live electrical services	Good Condition; no visible damage	<1m ²	Non-Friable	Low	Yes - Presumed.	6 - Very Low	<ol style="list-style-type: none"> No urgent remedial action required. Confirm presence of ACM through laboratory testing before refurbishment or demolition. Notify all contractors of the materials presence before works commence in this area. Re-inspect condition periodically. Manage material in accordance with asbestos management plan (AMP).

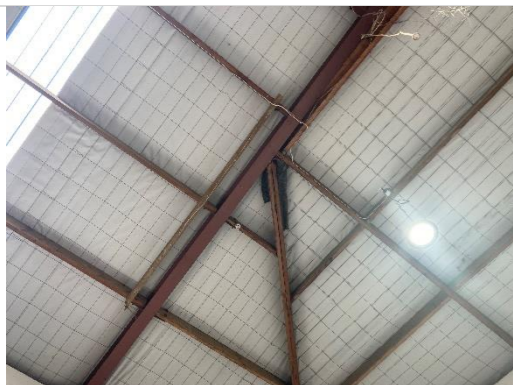
Bituminous roof sheeting material above the rafter on the south-eastern side of Building 13	Presumed ACM - Unable to inspect due to inaccessibility	Low Damage; few visible scratches, surface marks and broken edges	<1m ²	Non-Friable	Low	Yes - Presumed.	8 - Very Low	<ol style="list-style-type: none"> No urgent remedial action required. Confirm presence of ACM through laboratory testing before refurbishment or demolition. Notify all contractors of the materials presence before works commence in this area. Re-inspect condition periodically. Manage material in accordance with asbestos management plan (AMP).

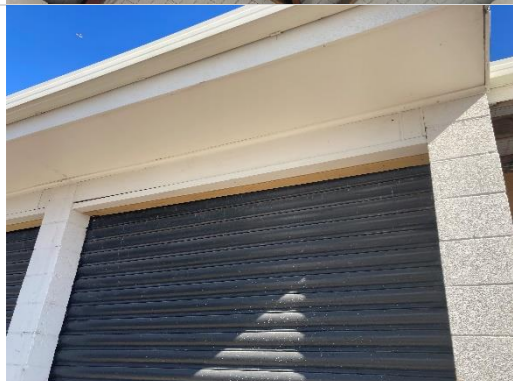
Fibre cement soffit and infill panels on the eastern side of the building	Strongly Presumed - Asbestos has been confirmed in similar looking materials	Good Condition; no visible damage	20m ²	Non-Friable	Low	Yes - Presumed.	8 - Very Low	<ol style="list-style-type: none"> Re-inspect condition periodically. Manage material in accordance with asbestos management plan (AMP).

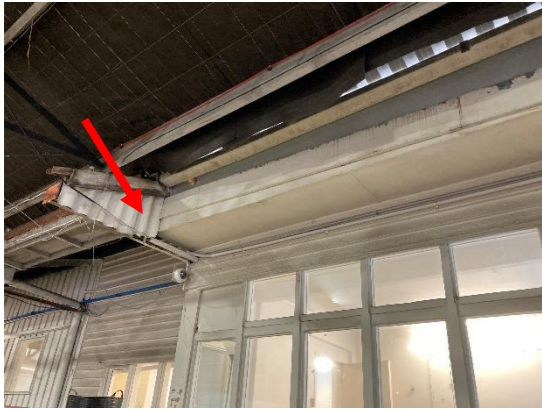
Corrugated fibre cement panel in the north-eastern corner of the building.	Presumed - Same as Sample # 5 Laboratory Reference Number 1600203.5	Low Damage; few visible scratches, surface marks and broken edges	<2m ²	Non-Friable	Low	Yes - Presumed.	9 - Low	<ol style="list-style-type: none"> No urgent remedial action required. Confirm presence of ACM through laboratory testing before refurbishment or demolition. Notify all contractors of the materials presence before works commence in this area. Re-inspect condition periodically. Manage material in accordance with AMP.
 	Electrical flashboards and fuse backings behind the office area.	Presumed ACM - Unable to sample due to live electrical services	Low Damage; few visible scratches, surface marks and broken edges	<1m ²	Non-Friable	Low	Yes - Presumed.	7 - Very Low	<ol style="list-style-type: none"> No urgent remedial action required. Confirm presence of ACM through laboratory testing before refurbishment or demolition. Notify all contractors of the materials presence before works commence in this area. Re-inspect condition periodically. Manage material in accordance with AMP.

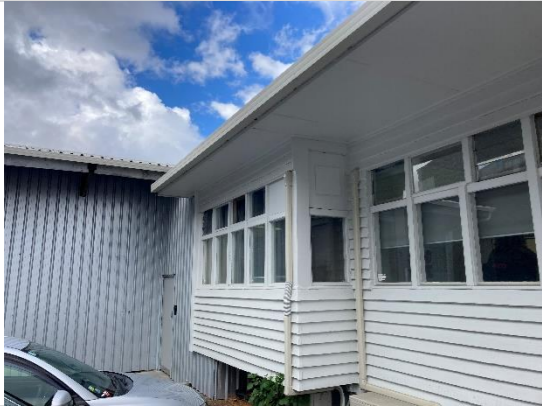
Presumed - Same as Sample # 6 Laboratory Reference Number 1600203.6	Good Condition; no visible damage	<15m2	Non-Friable	Low	Chrysotile detected.	8 - Very Low	<ol style="list-style-type: none"> No urgent remedial action required. Notify all contractors of the materials presence before works commence in this area. Re-inspect condition periodically. Manage material in accordance with AMP.

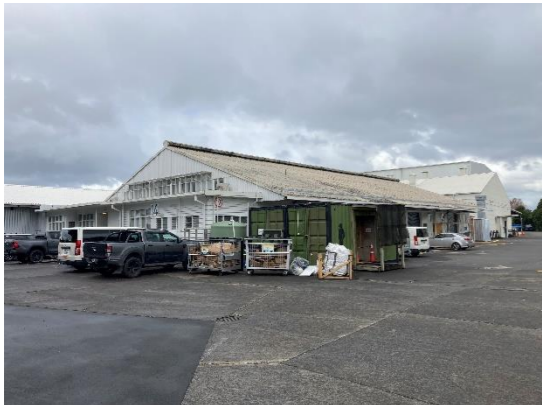
Sampled - # 5 Laboratory Reference Number 1600203.5	Low Damage; few visible scratches, surface marks and broken edges	900m ²	Non-Friable	Low	Amosite and Chrysotile detected.	11 - Low	<ol style="list-style-type: none"> No urgent remedial action required. Notify all contractors of the materials presence before works commence in this area. Re-inspect condition periodically. Full PPE and RPE (e.g. P3) must be worn when removing debris from the gutter Debris in the gutter must be removed wet All debris removed from the gutter must be disposed of as asbestos contaminated waste Manage material in accordance with AMP.

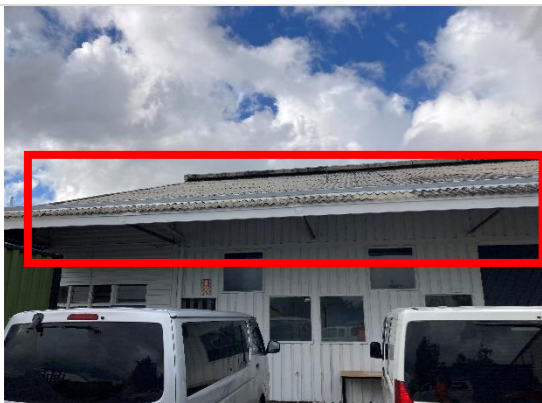
Presumed - Same as Sample # 5 Laboratory Reference Number 1600203.5	Low Damage; few visible scratches, surface marks and broken edges		Non-Friable	Low	Amosite and Chrysotile detected.	11 - Low	<ol style="list-style-type: none"> Install gutters, rain headers and downpipes on this section of the roof. Notify all contractors of the materials presence before works commence in this area. Re-inspect condition periodically. Manage material in accordance with AMP.

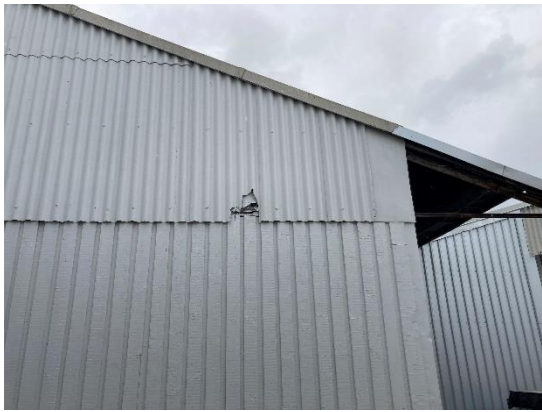
<p>Corrugated fibre cement ('Super-12') cladding on the upper half of the southern end of the building. Please refer to Appendix B for additional photographs.</p>	Presumed - Same as Sample # 5 Laboratory Reference Number 1600203.5	Low Damage; few visible scratches, surface marks and broken edges	50m2	Non-Friable	Low	Yes - Presumed.	11 - Low	<ol style="list-style-type: none"> No urgent remedial action required. Confirm presence of ACM through laboratory testing before refurbishment or demolition. Notify all contractors of the materials presence before works commence in this area. Re-inspect condition periodically. Manage material in accordance with AMP.

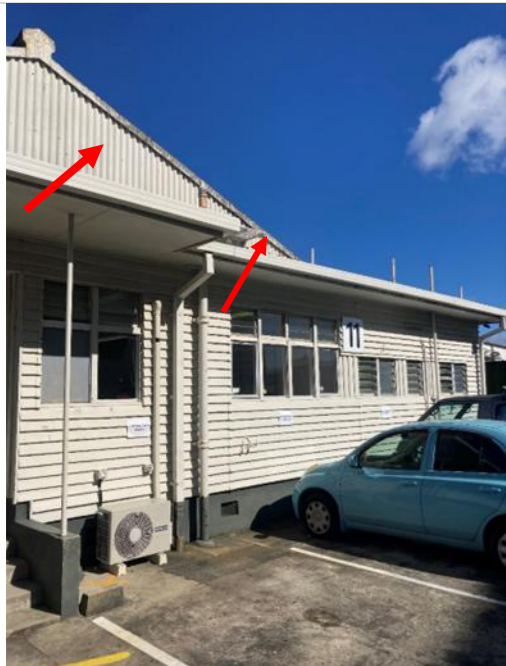
<p>Corrugated fibre cement gable ends on the northern end of the building. Please refer to Appendix B for additional photographs.</p>	Presumed - Same as Sample # 5 Laboratory Reference Number 1600203.5	Low Damage; few visible scratches, surface marks and broken edges	30m2	Non-Friable	Low	Yes - Presumed.	9 - Low	<ol style="list-style-type: none"> No urgent remedial action required. Confirm presence of ACM through laboratory testing before refurbishment or demolition. Notify all contractors of the materials presence before works commence in this area. Re-inspect condition periodically. Manage material in accordance with AMP.

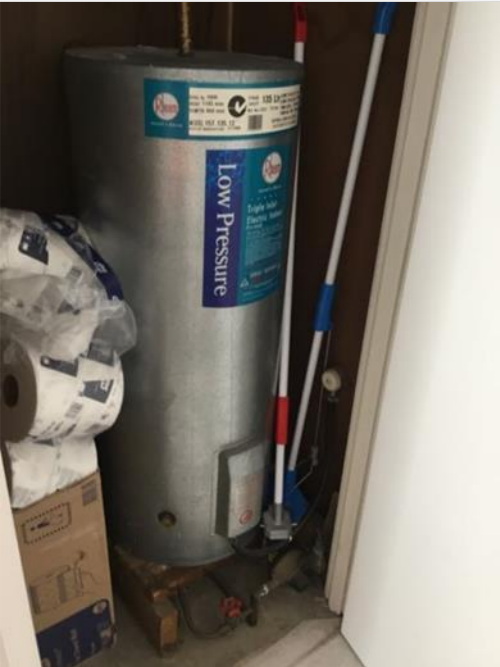
Bakelite switch in the hot water cupboard in the male toilets.	Presumed ACM - Unable to sample due to live electrical services	Good Condition; no visible damage	<1m ²	Non-Friable	Very Low	Presumed Asbestos	7 - Very Low	<ol style="list-style-type: none"> 1. No urgent remedial action required. 2. Notify all contractors of the materials presence before works commence in this area. 3. Label and re-inspect condition periodically. 4. Confirm the presence or absence of asbestos prior to refurbishment or demolition. 5. Manage material in accordance with asbestos management plan (AMP).

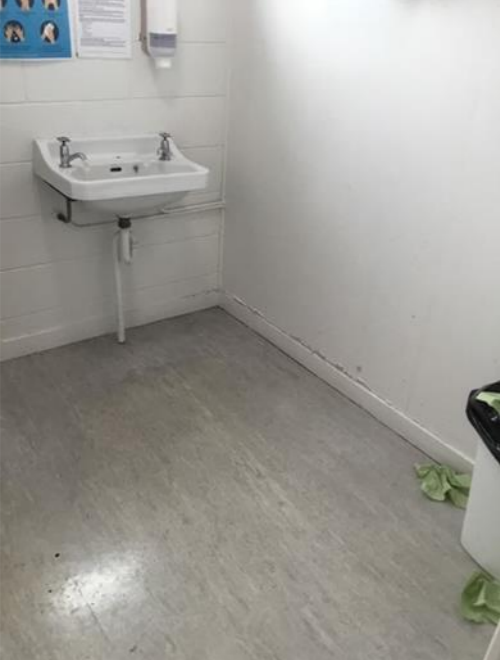
Grey vinyl floors and residual materials underneath it in the male toilets.	Presumed ACM - Sampling will affect the material's integrity	Low Damage; few visible scratches, surface marks and broken edges	5m ²	Non-Friable	Very Low	Presumed Asbestos	8 - Very Low	<ol style="list-style-type: none"> 1. No urgent remedial action required. 2. Notify all contractors of the materials presence before works commence in this area. 3. Label and re-inspect condition periodically. 4. Confirm the presence or absence of asbestos prior to refurbishment or demolition. 5. Manage material in accordance with asbestos management plan (AMP).

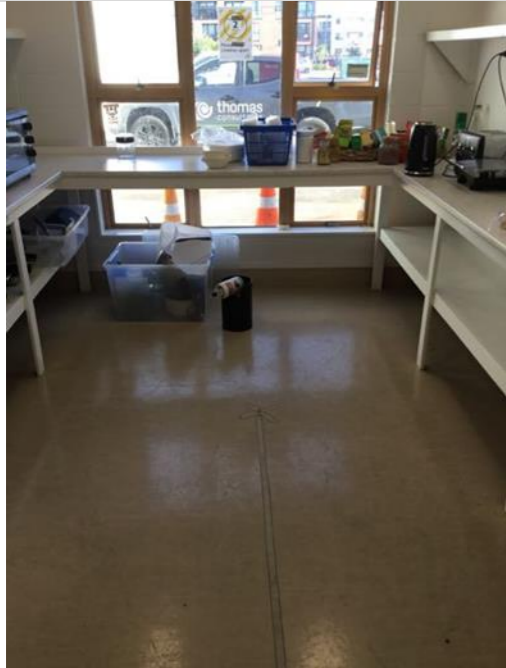
Beige vinyl floor and residual materials underneath it located in the kitchen.	Presumed ACM - Sampling will affect the material's integrity	Low Damage; few visible scratches, surface marks and broken edges	10m ²	Non-Friable	Very Low	Presumed Asbestos	8 - Very Low	<ol style="list-style-type: none"> 1. No urgent remedial action required. 2. Notify all contractors of the materials presence before works commence in this area. 3. Label and re-inspect condition periodically. 4. Confirm the presence or absence of asbestos prior to refurbishment or demolition. 5. Manage material in accordance with asbestos management plan (AMP).

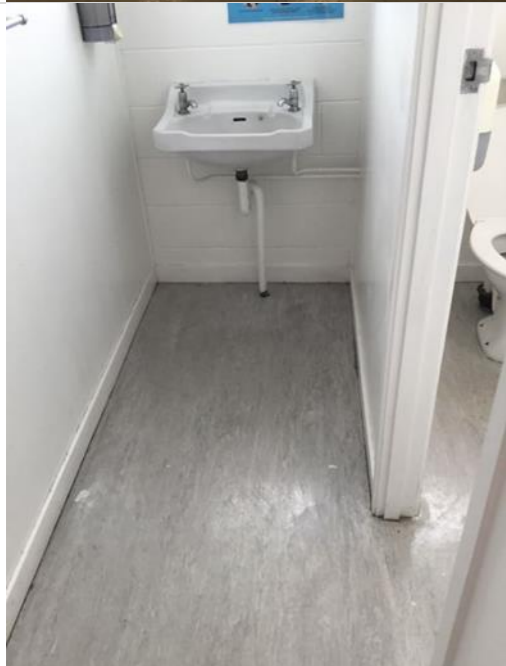
Grey vinyl floor and residual materials underneath it in the female toilets	Presumed ACM - Sampling will affect the material's integrity	Low Damage; few visible scratches, surface marks and broken edges	5m ²	Non-Friable	Very Low	Presumed Asbestos	8 - Very Low	<ol style="list-style-type: none"> 1. No urgent remedial action required. 2. Notify all contractors of the materials presence before works commence in this area. 3. Label and re-inspect condition periodically. 4. Confirm the presence or absence of asbestos prior to refurbishment or demolition. 5. Manage material in accordance with asbestos management plan (AMP).

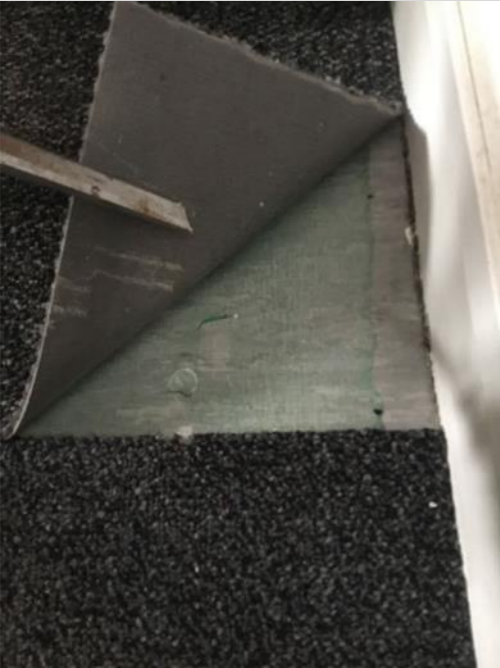
Vinyl floors underneath the carpets throughout the building.	Presumed ACM - Sampling will affect the material's integrity	Low Damage; few visible scratches, surface marks and broken edges	30m ²	Non-Friable	Very Low	Presumed Asbestos	8 - Very Low	<ol style="list-style-type: none"> 1. No urgent remedial action required. 2. Notify all contractors of the materials presence before works commence in this area. 3. Label and re-inspect condition periodically. 4. Confirm the presence or absence of asbestos prior to refurbishment or demolition. 5. Manage material in accordance with asbestos management plan (AMP).

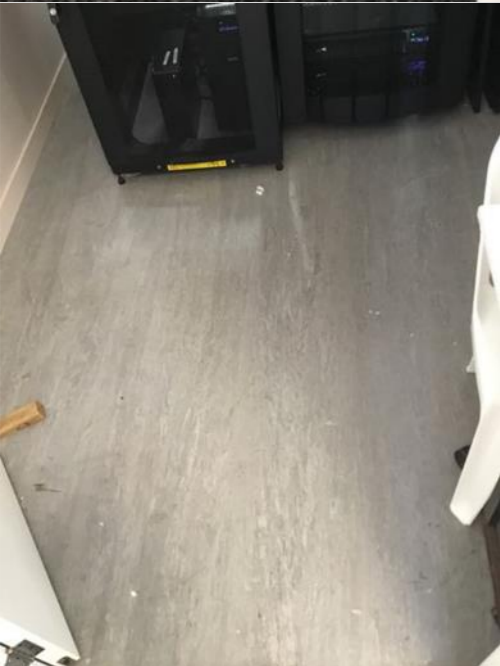
Grey vinyl floors and residual materials underneath it in Cabinet A and B.	Presumed ACM - Sampling will affect the material's integrity	Low Damage; few visible scratches, surface marks and broken edges	5m ²	Non-Friable	Very Low	Presumed Asbestos	8 - Very Low	<ol style="list-style-type: none"> 1. No urgent remedial action required. 2. Notify all contractors of the materials presence before works commence in this area. 3. Label and re-inspect condition periodically. 4. Confirm the presence or absence of asbestos prior to refurbishment or demolition. 5. Manage material in accordance with asbestos management plan (AMP).

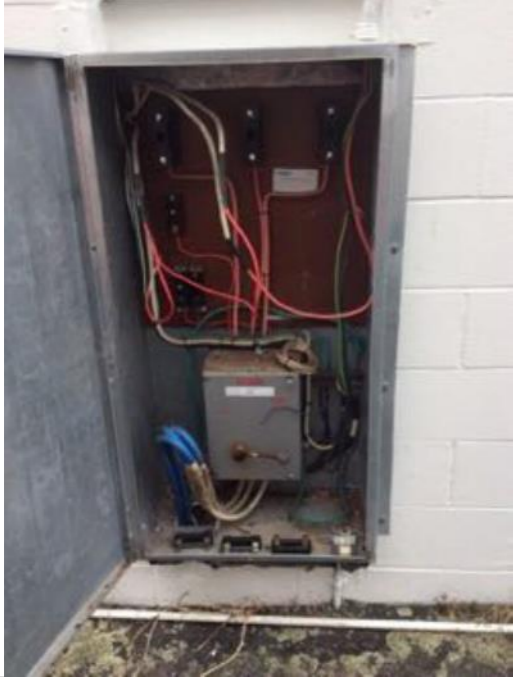
<p>Switchboard backing and insulating rope (flash guard) behind the fuses in the electrical box on the western side of the vestibule (exterior).</p>	Presumed ACM - Unable to sample due to live electrical services	Good Condition; no visible damage	<1m ²	Non-Friable	Very Low	Presumed Asbestos	6 – Very Low	<ol style="list-style-type: none"> 1. No urgent remedial action required. 2. Notify all contractors of the materials presence before works commence in this area. 3. Label and re-inspect condition periodically. 4. Confirm the presence or absence of asbestos prior to refurbishment or demolition. 5. Manage material in accordance with asbestos management plan (AMP).

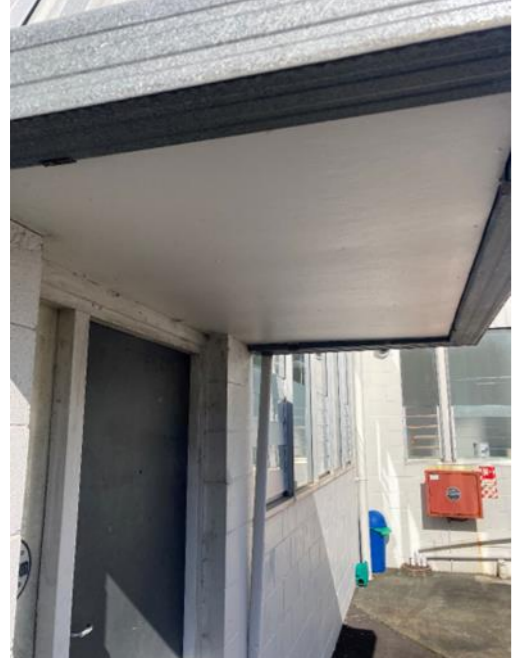
<p>Fibre cement soffits by the three entrance ways on the western side of the building. Please refer to Appendix B for additional photographs.</p>	Strongly Presumed - Asbestos has been confirmed in similar looking materials	Good Condition; no visible damage	<10m ²	Non-Friable	Low	Presumed Asbestos	8 - Very Low	<ol style="list-style-type: none"> 1. No urgent remedial action required. 2. Notify all contractors of the materials presence before works commence in this area. 3. Label and re-inspect condition periodically. 4. Confirm the presence or absence of asbestos prior to refurbishment or demolition. 5. Manage material in accordance with asbestos management plan (AMP).

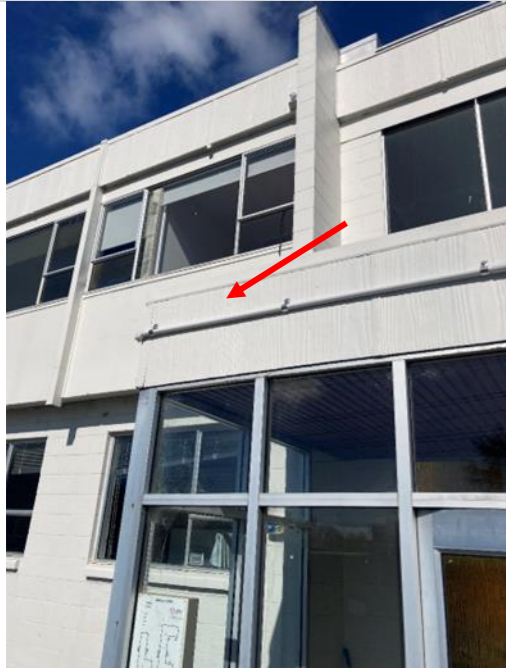
<p>Wood-grain patterned fibre cement cladding around the northern and western sides of the first floor and the vestibule area. Please refer to Appendix B for additional photographs.</p>	Presumed ACM - Sampling will affect building aesthetics	Good Condition; no visible damage	<50m ²	Non-Friable	Very Low	Presumed Asbestos	8 - Very Low	<ol style="list-style-type: none"> 1. No urgent remedial action required. 2. Notify all contractors of the materials presence before works commence in this area. 3. Label and re-inspect condition periodically. 4. Confirm the presence or absence of asbestos prior to refurbishment or demolition. 5. Manage material in accordance with asbestos management plan (AMP).

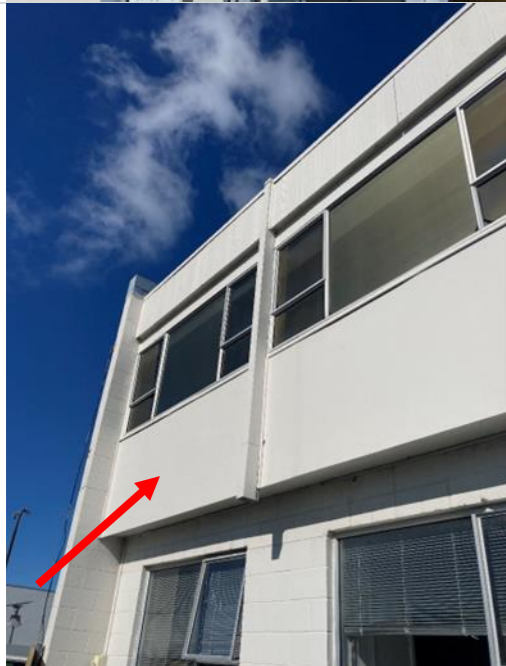
<p>Fibre cement boards with textured coating on the northern, southern and western sides of the building. Please refer to Appendix B for additional photographs.</p>	Presumed ACM - Unable to inspect due to inaccessibility	Good Condition; no visible damage	<30m ²	Non-Friable	Very Low	Presumed Asbestos	8 - Very Low	<ol style="list-style-type: none"> 1. No urgent remedial action required. 2. Notify all contractors of the materials presence before works commence in this area. 3. Label and re-inspect condition periodically. 4. Confirm the presence or absence of asbestos prior to refurbishment or demolition. 5. Manage material in accordance with asbestos management plan (AMP).

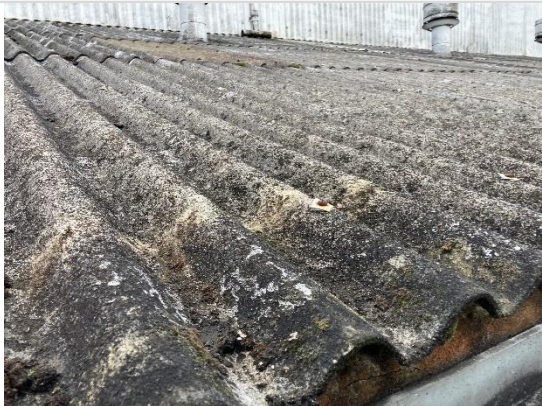
Corrugated fibre cement "super-six" roofing material covering the entirety of the main building. Please refer to Appendix B for additional photographs.	Sampled - # 1 Laboratory Reference Number A-00843/1	Low Damage; few visible scratches, surface marks and broken edges	<500m ²	Non-Friable	Low	Amosite (Brown Asbestos) and Chrysotile (White Asbestos) detected.	12 - Low	<ol style="list-style-type: none"> No urgent remedial action required. Notify all contractors of the materials presence before works commence in this area. Label and re-inspect condition periodically. Manage material in accordance with asbestos management plan (AMP).

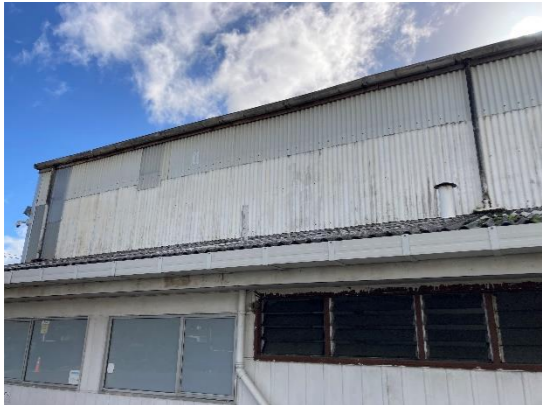
Corrugated fibre cement "super-six" wall cladding covering the northern, eastern, and western sides of the main building. Please refer to Appendix B for additional photographs.	Sampled - # 11 & 14 Laboratory Reference Numbers A-00843/11 & A-00843/14	Medium Damage; significant breakage or several small areas of damage revealing loose fibres	<500m ²	Non-Friable	Low	Amosite and Chrysotile detected.	13 - Low	<ol style="list-style-type: none"> No urgent remedial action required. Notify all contractors of the materials presence before works commence in this area. Label and re-inspect condition periodically. Manage material in accordance with AMP.

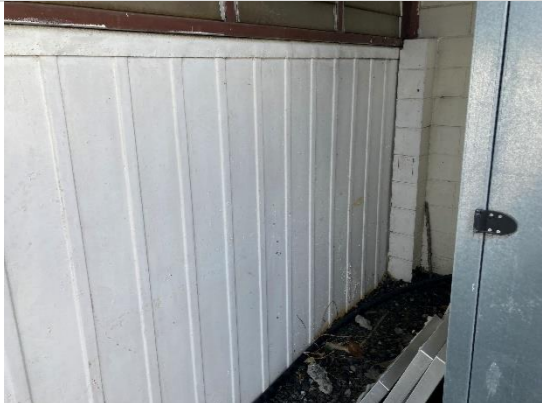
Corrugated fibre cement wall cladding lining the southern side of the building. Please refer to Appendix B for additional photographs.	Sampled - # 7 Laboratory Reference Number A-00843/7	Low Damage; few visible scratches, surface marks and broken edges	<100m ²	Non-Friable	Low	Amosite and Chrysotile detected.	10 - Low	<ol style="list-style-type: none"> No urgent remedial action required. Notify all contractors of the materials presence before works commence in this area. Label and re-inspect condition periodically. Manage material in accordance with AMP.

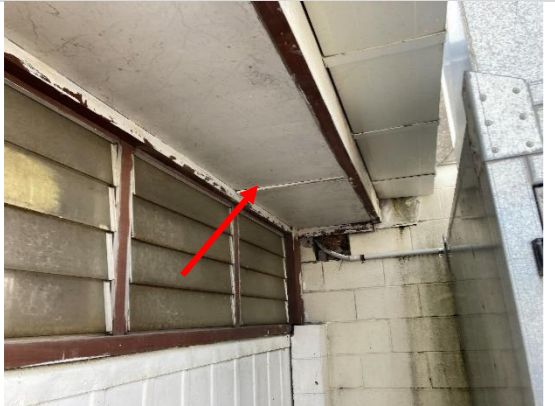
Fibre cement soffits on the eastern and western sides of the AA Carriers office and on the southern side of the warehouse.	Sampled - # 10 Laboratory Reference Number A-00843/10	Low Damage; few visible scratches, surface marks and broken edges	<60m ²	Non-Friable	Low	Amosite and Chrysotile detected.	8 - Very Low	<ol style="list-style-type: none"> No urgent remedial action required. Notify all contractors of the materials presence before works commence in this area. Re-inspect condition periodically. Manage material in accordance with AMP.

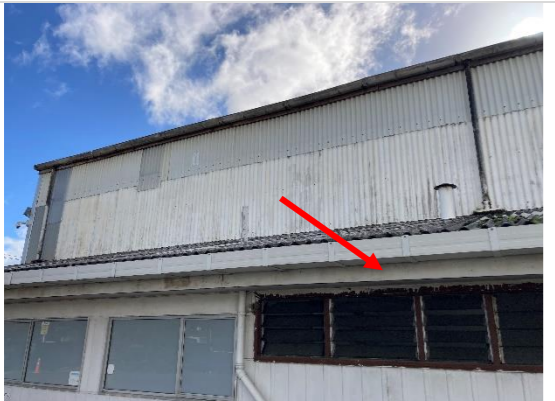
Fibre cement fascia panels on the southern end of the warehouse.	Sampled - # 17 Laboratory Reference Number A-00843/17	Low Damage; few visible scratches, surface marks and broken edges	10m ²	Non-Friable	Low	Amosite and Chrysotile detected.	8 - Very Low	<ol style="list-style-type: none"> No urgent remedial action required. Notify all contractors of the materials presence before works commence in this area. Re-inspect condition periodically. Manage material in accordance with AMP.

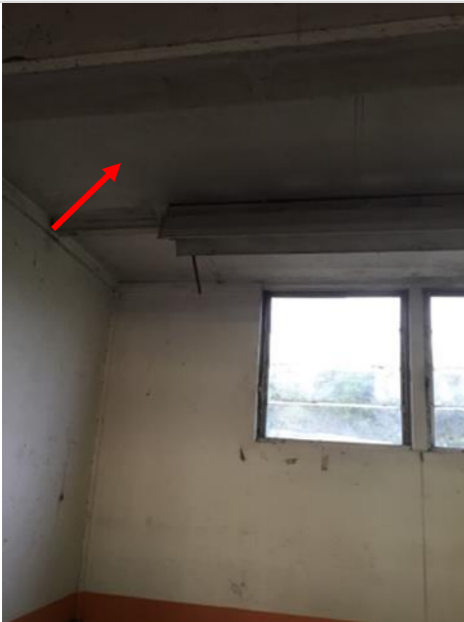
Fibre cement ceiling panel on the southern end of the warehouse.	Sampled - # 2 Laboratory Reference Number 2205570.2	Good Condition; no visible damage	<10m ²	Non-Friable	Low	Amosite, Chrysotile and Crocidolite (Blue Asbestos) detected.	8 - Very Low	<ol style="list-style-type: none"> No urgent remedial action required. Notify all contractors of the materials presence before works commence in this area. Re-inspect condition periodically. Manage material in accordance with AMP.

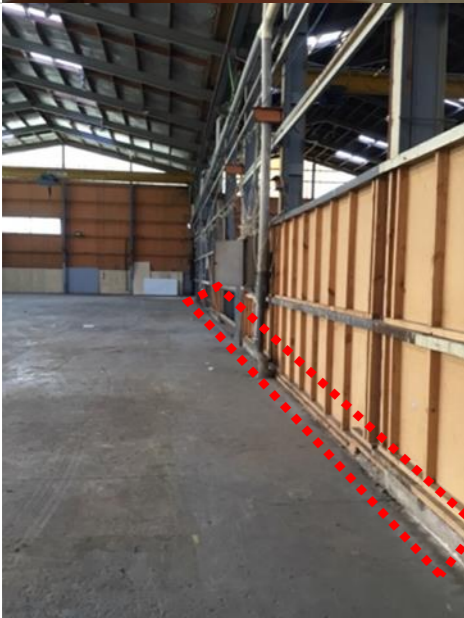
Fibre cement "super-six" debris embedded in the concrete floor running down the centre of the dividing wall on the eastern side of the building.	Presumed - Same as Sample # 1 Laboratory Reference Number A-00843/1	Good Condition; no visible damage	<10m ²	Non-Friable	Low	Amosite, Chrysotile and Crocidolite detected.	9 - Low	<ol style="list-style-type: none"> No urgent remedial action required. Notify all contractors of the materials presence before works commence in this area. Re-inspect condition periodically. Manage material in accordance with AMP.

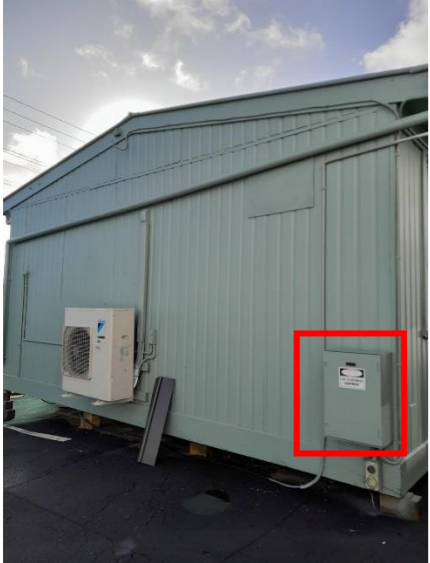
<p>Flashboard and flash guards in the electrical board on the western side of the building</p>	Presumed ACM - Unable to sample due to live electrical services	Good Condition; no visible damage	<1m ²	Non-Friable	Low	Yes - Presumed.	6 - Very Low	<ol style="list-style-type: none"> 1. No urgent remedial action required. 2. Confirm presence of ACM through laboratory testing before refurbishment or demolition. 3. Notify all contractors of the materials presence before works commence in this area. 4. Re-inspect condition periodically. 5. Manage material in accordance with AMP.

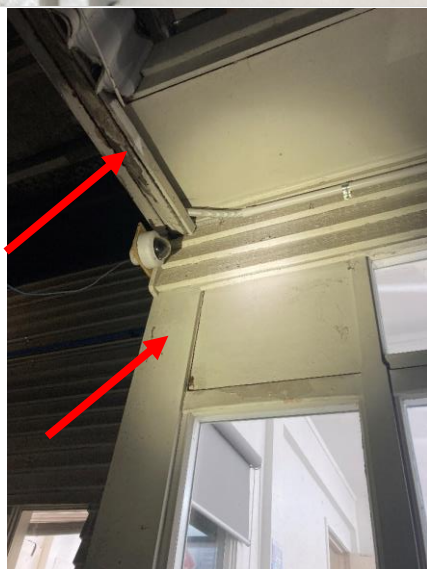
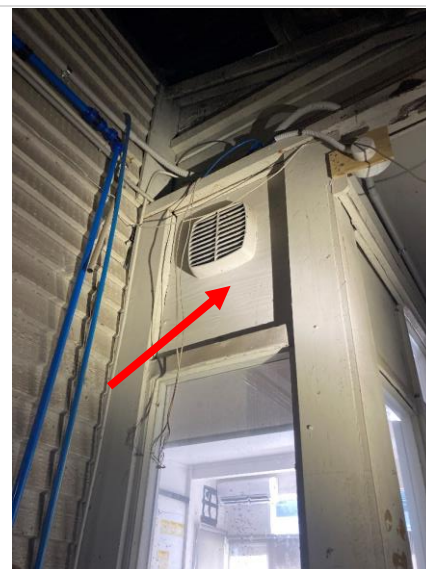
Fibre cement soffits on the northern and western sides of building.

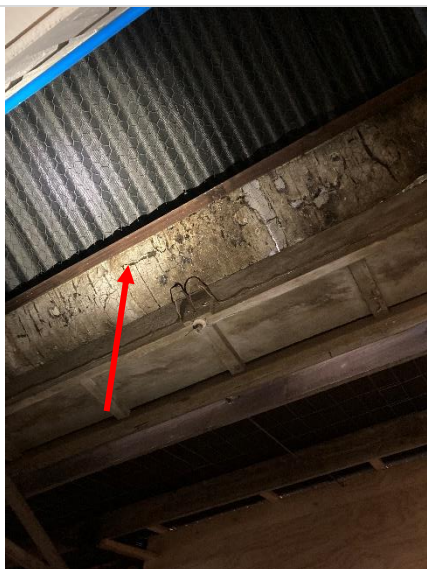
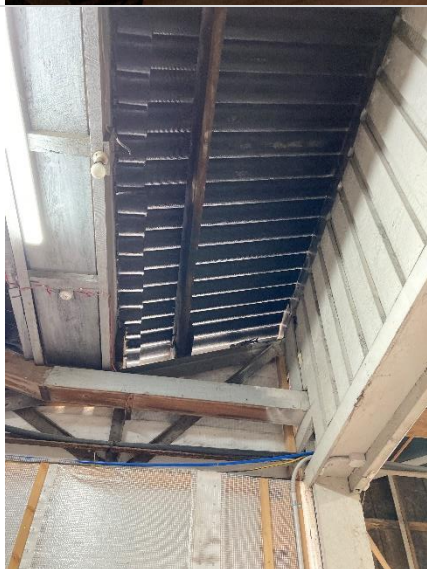
Corrugated fibre cement ('Super-12') cladding on the upper half of the southern end of the building.

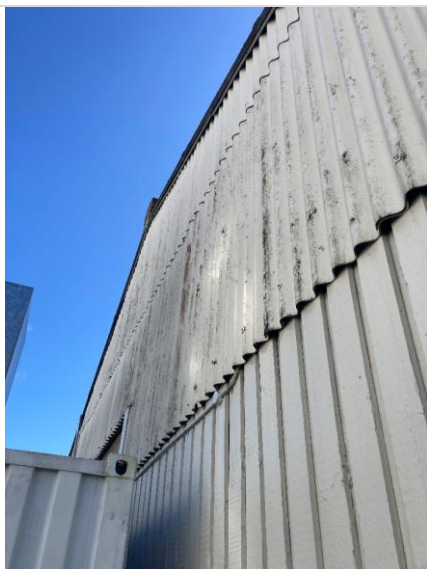
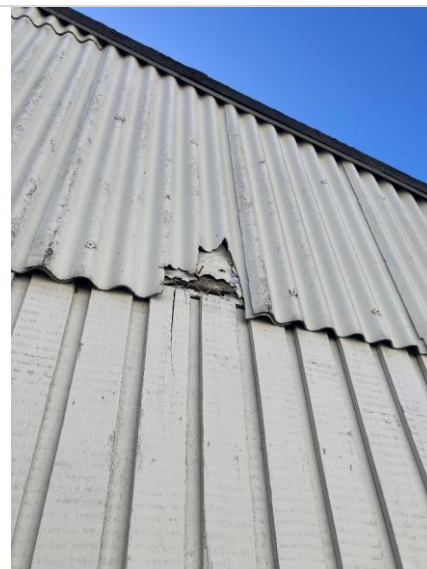
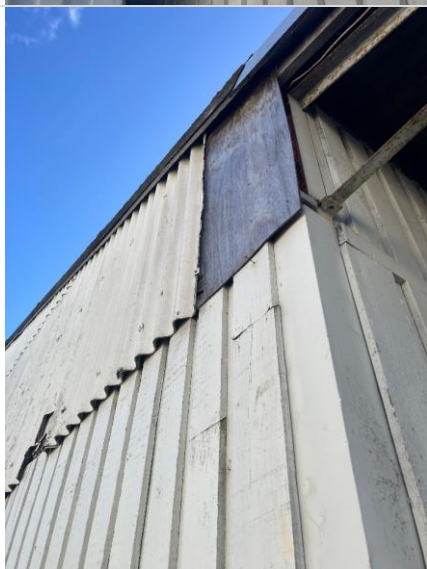
Corrugated fibre cement gable ends on the northern end of the building.

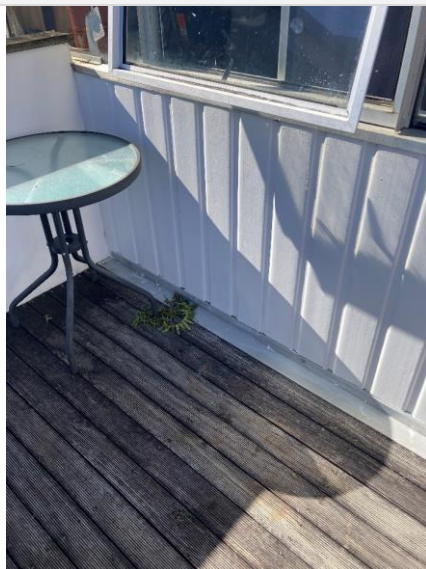
Corrugated fibre cement cladding on the western and south-western sides of the ground and first floors.

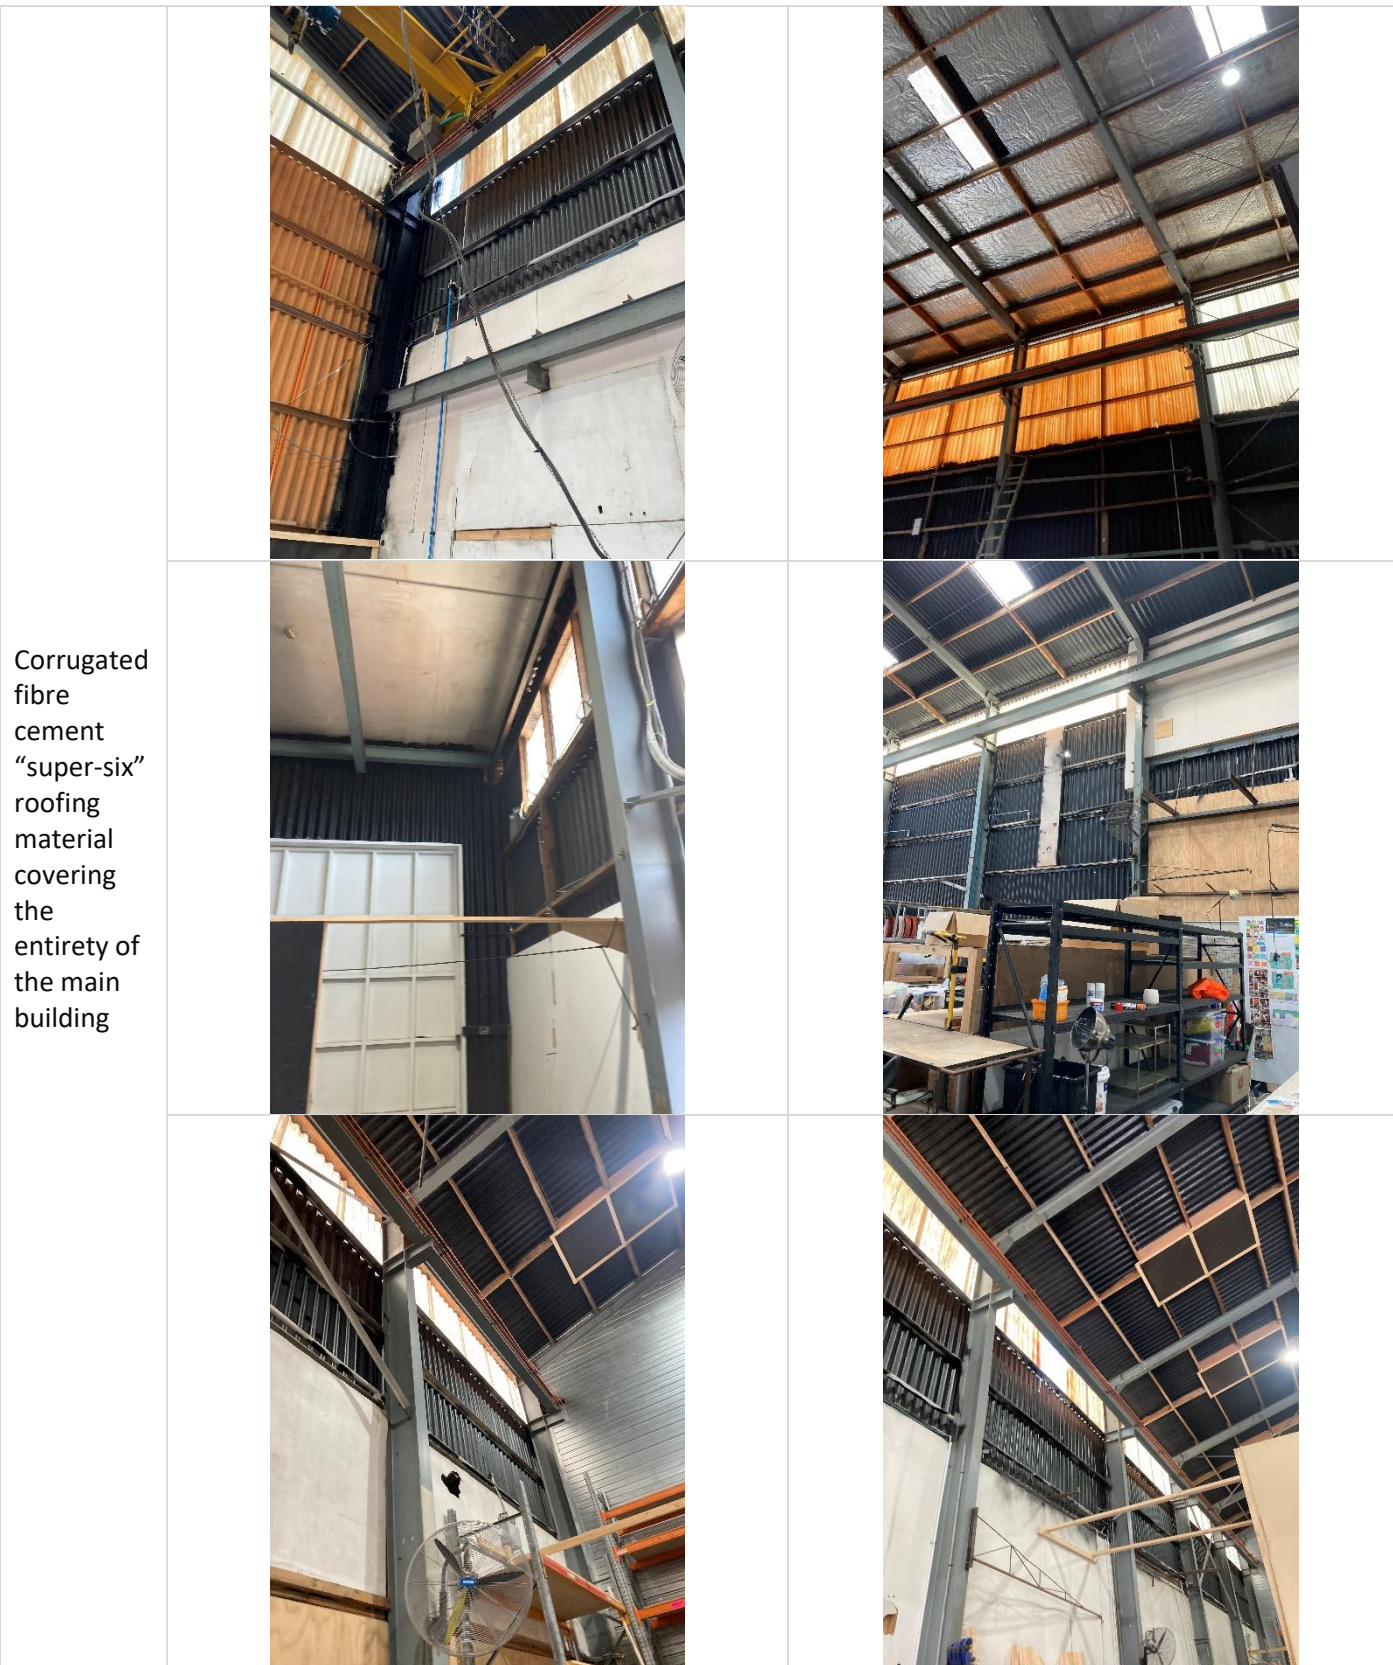
Corrugated fibre cement “super-six” roofing material covering the entirety of the main building
