ASBESTOS MANAGEMENT PLAN

Auckland Film Studios

12 Hickory Avenue Henderson, Auckland

Project ID: ECON3748-AMP

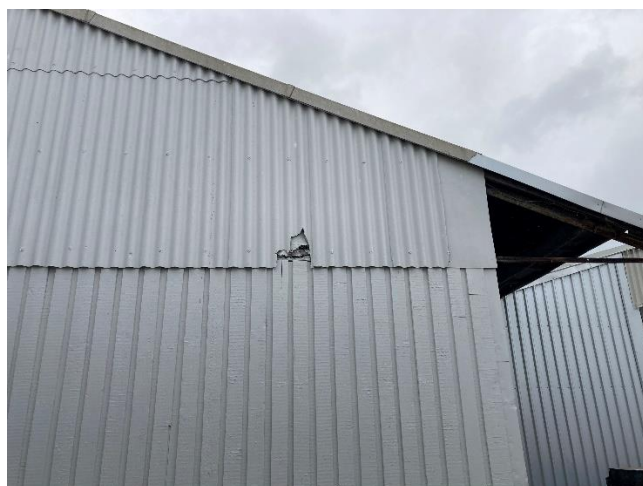
Corrugated fibre cement ('Super-12') cladding on the upper half of the southern end of the building.

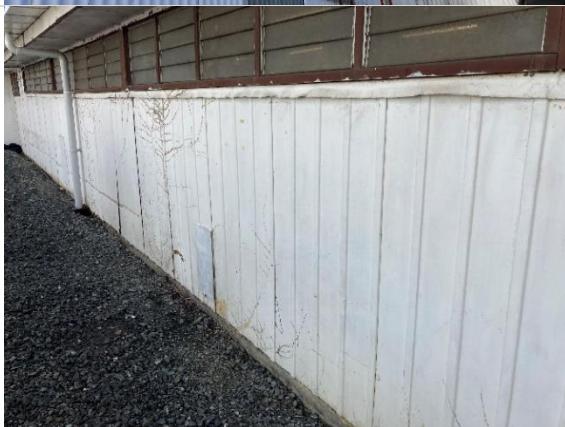
Corrugated fibre cement wall cladding on the southern side of the building.
