ASBESTOS MANAGEMENT PLAN

Auckland Film Studios

12 Hickory Avenue Henderson, Auckland

Project ID: ECON3748-AMP

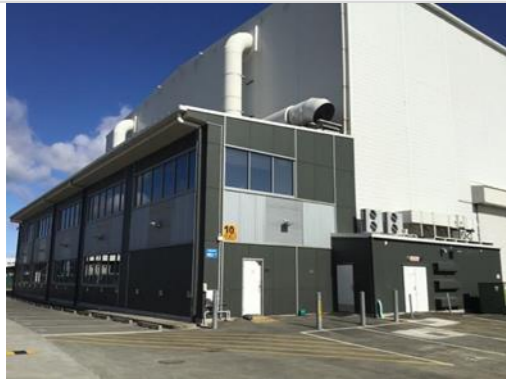
No asbestos containing materials identified within the building.	Visually Inspected - Not ACM	-	-	-	-	Asbestos NOT detected	N/A	N/A
Building 10

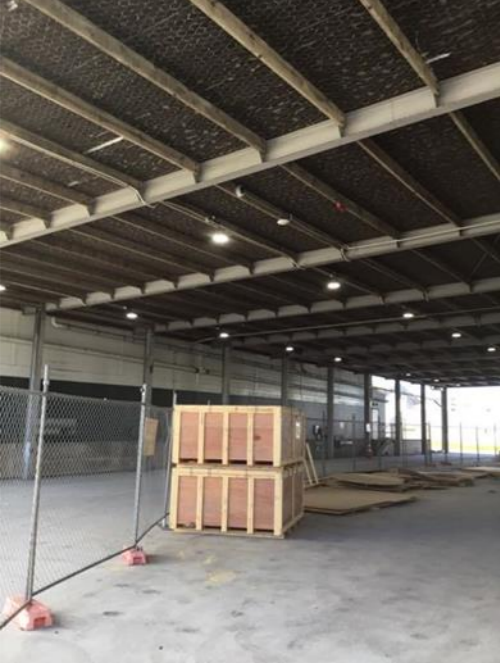
Roof sarking	Visually Inspected - Not ACM	-	200m ²	-	-	Asbestos NOT detected	N/A	N/A

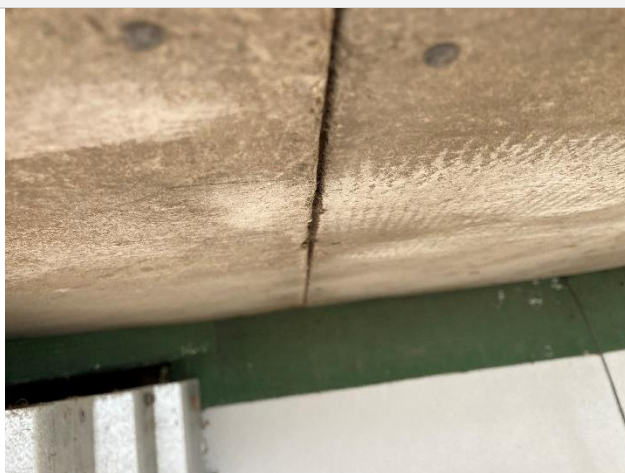
Fibre cement panels under the bay windows on the north-eastern corner of the building

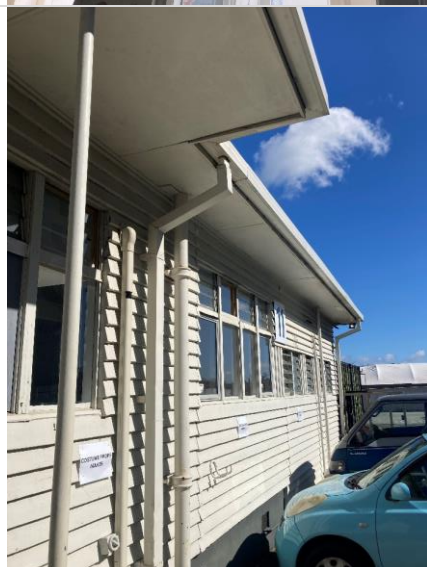
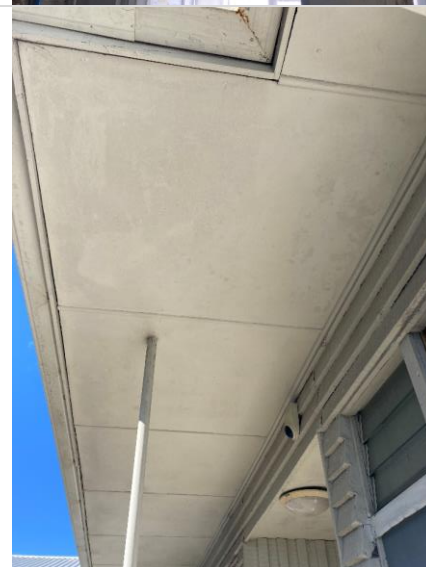
Fibre cement soffits on the northern and western sides of building.

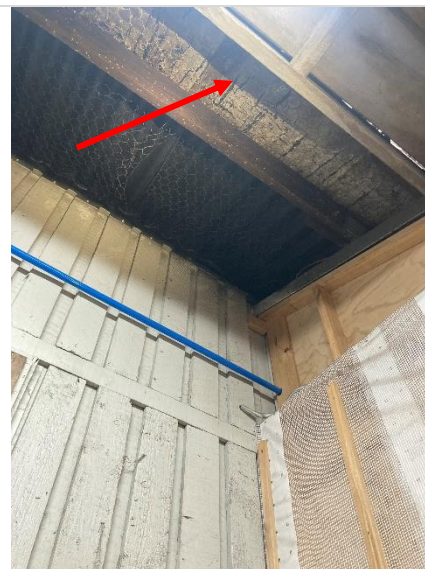
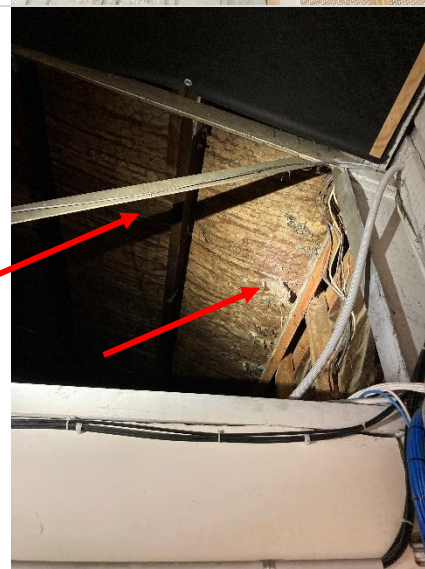
Corrugated fibre cement sheet roofing, flashings and associated ridge cap.

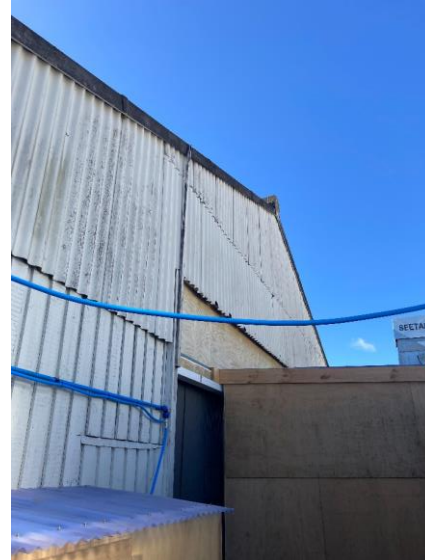
Corrugated fibre cement ('Super-12') cladding on the upper half of the southern end of the building.

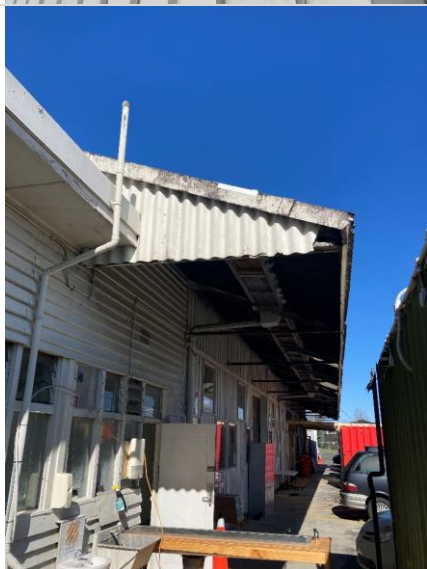
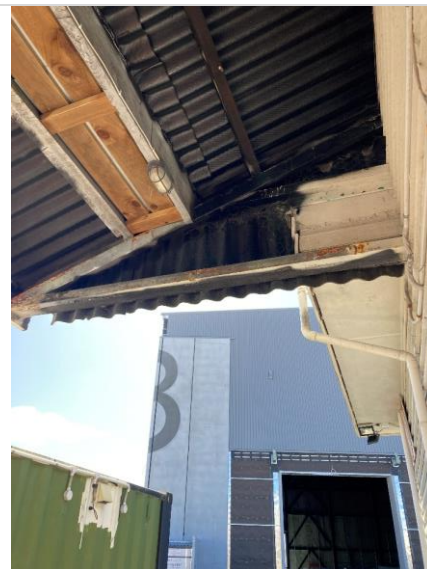
Corrugated fibre cement gable ends on the northern end of the building.

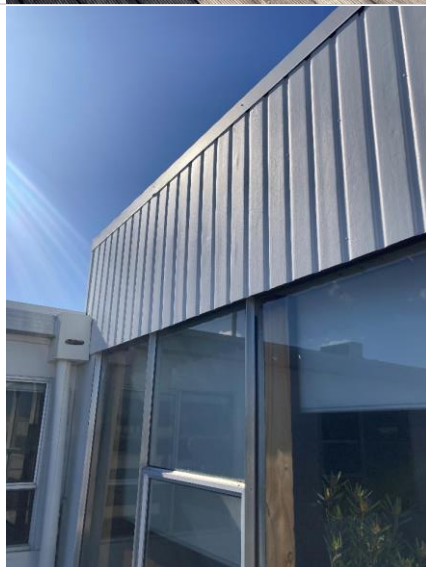
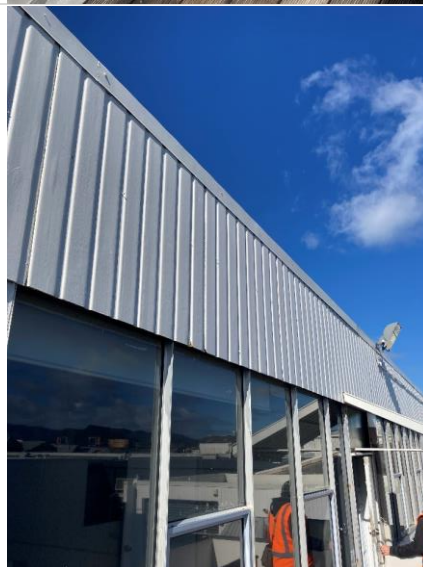
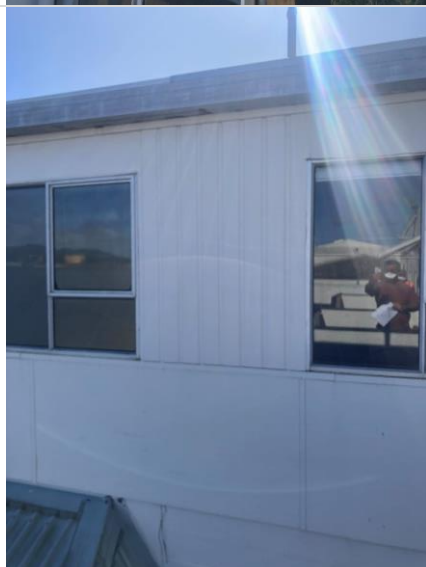
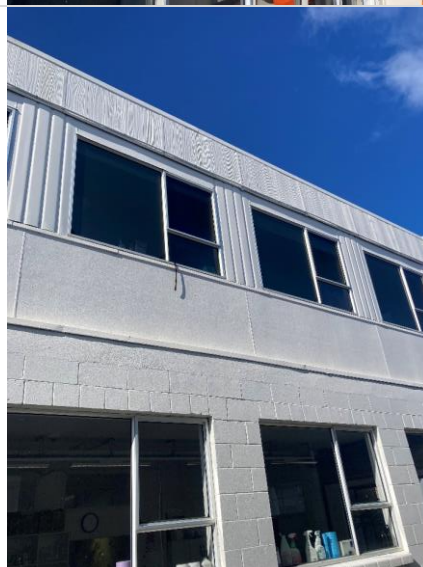
Corrugated fibre cement cladding on the western and south-western sides of the ground and first floors.

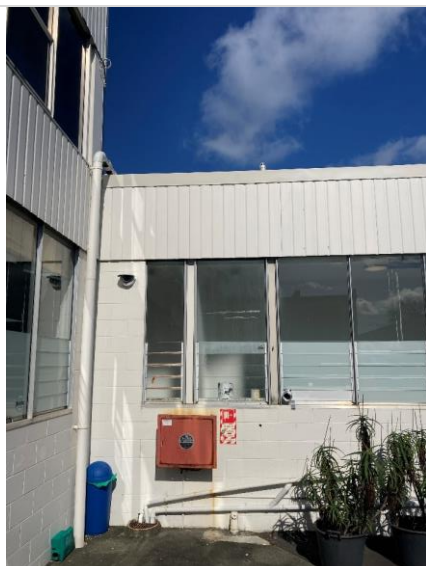
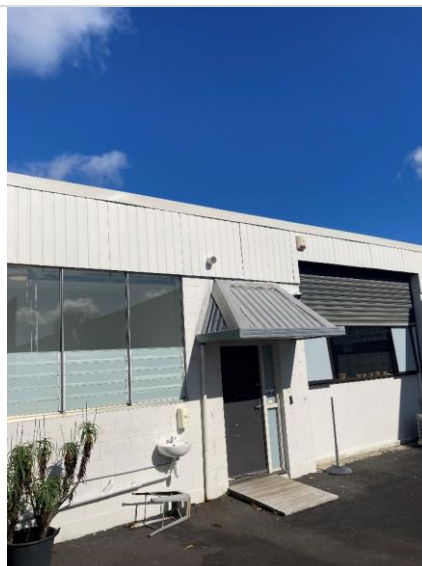
Corrugated fibre cement cladding on the western and south-western sides of the ground and first floors.

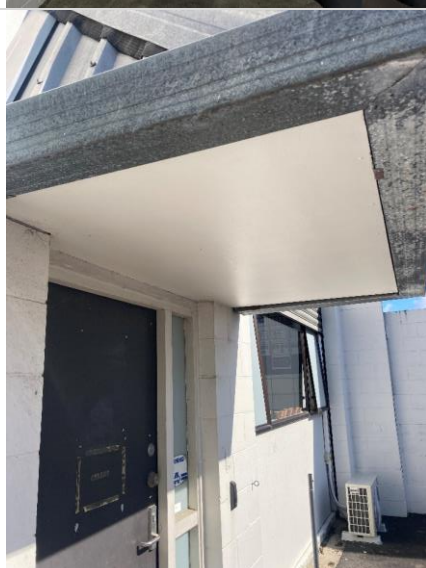
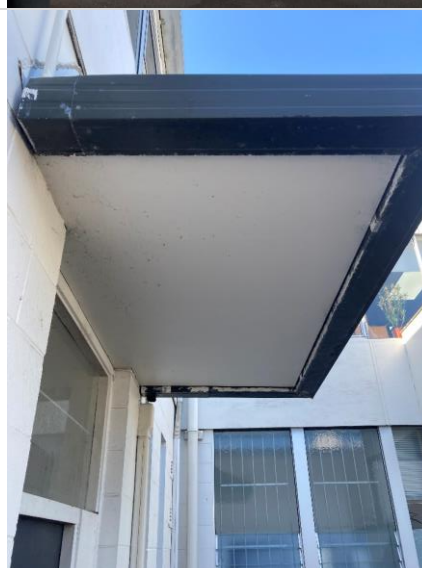
Fibre cement soffits by the three entrance ways on the western side of the building.

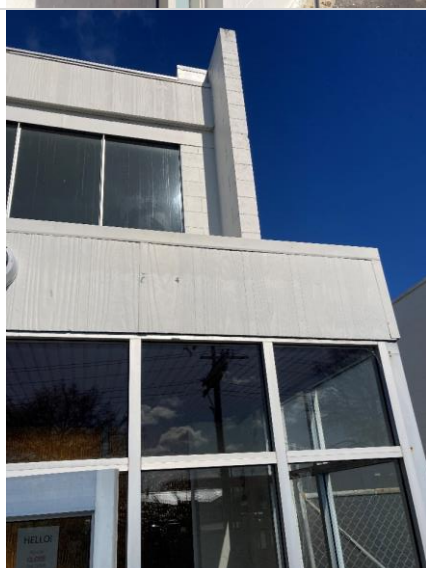
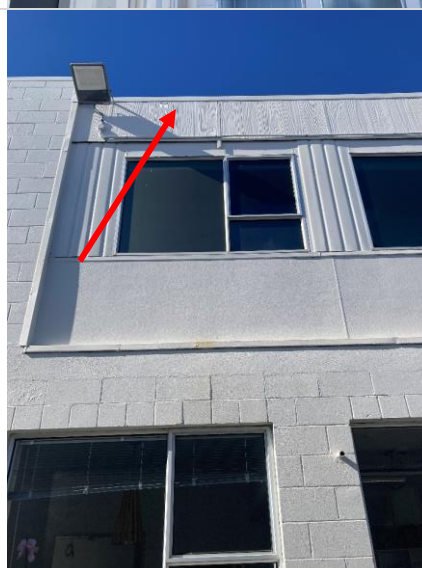
Woodgrain patterned fibre cement cladding around the northern and eastern sides of the first floor and the vestibule area.

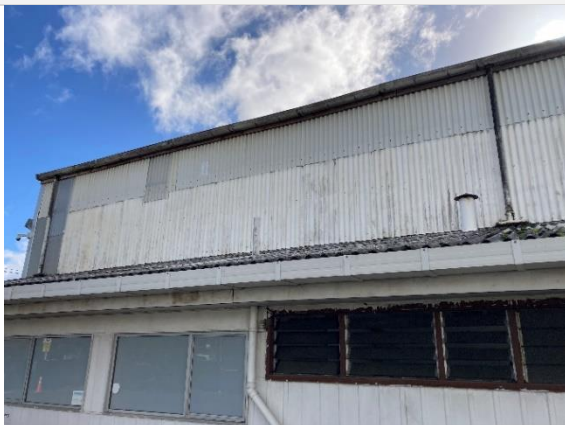
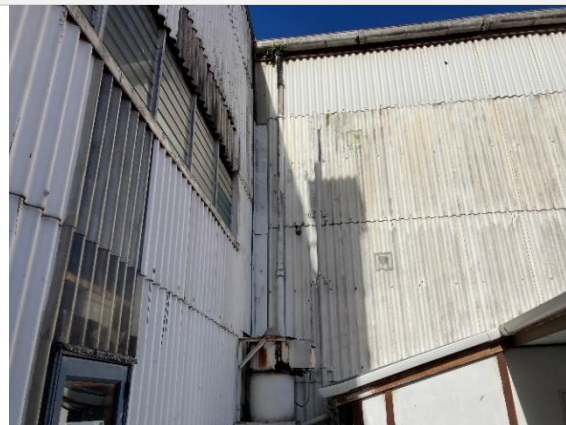
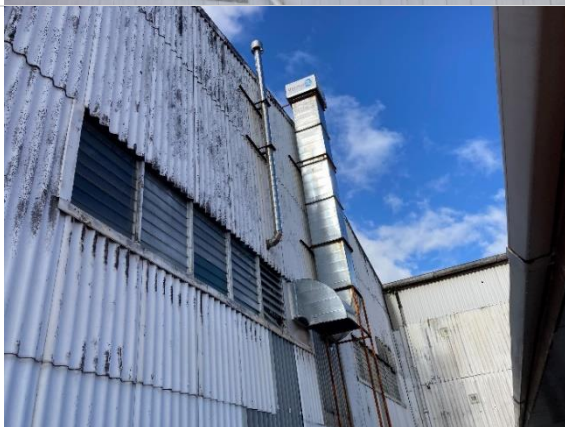
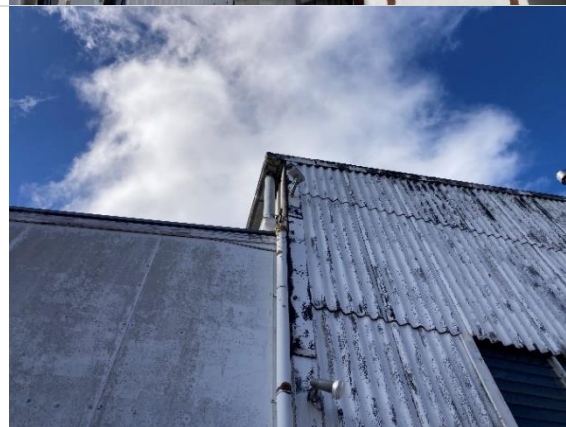
Fibre cement wall cladding on the building.

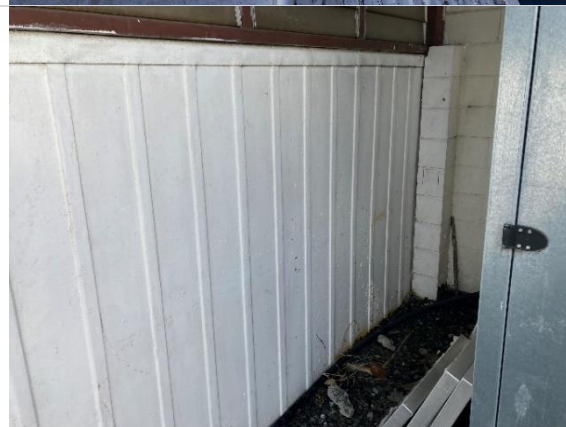
Corrugated fibre cement wall cladding on the southern side of the building.

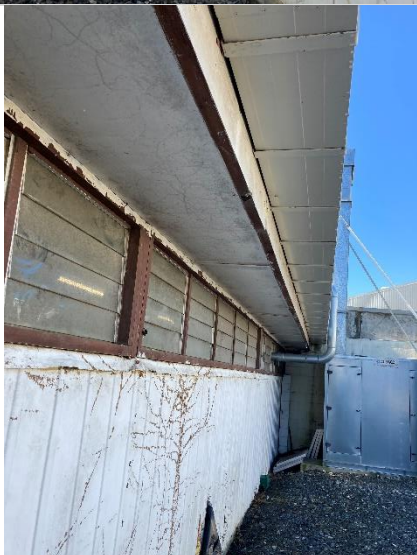
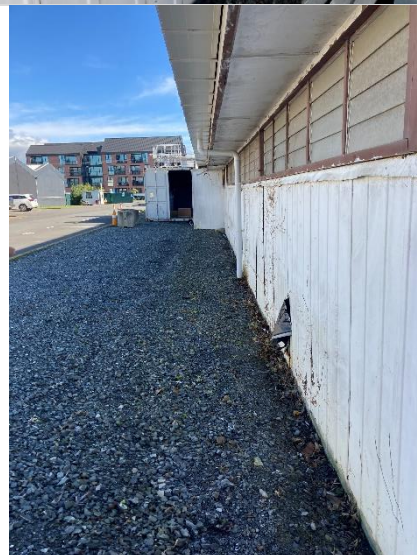
Corrugated fibre cement wall cladding on the southern side of the building.
